# REVIEW OF RESEARCH

VOLUME - 15 | ISSUE - 4 | JANUARY - 2026

## RIVER BANK EROSION AND ITS CONSEQUENCES IN AND AROUND MURSHIDABAD DISTRICT, WEST BENGAL (INDIA). STUDY AREA: EROSION-PRONE RIVERINE BELT OF MURSHIDABAD

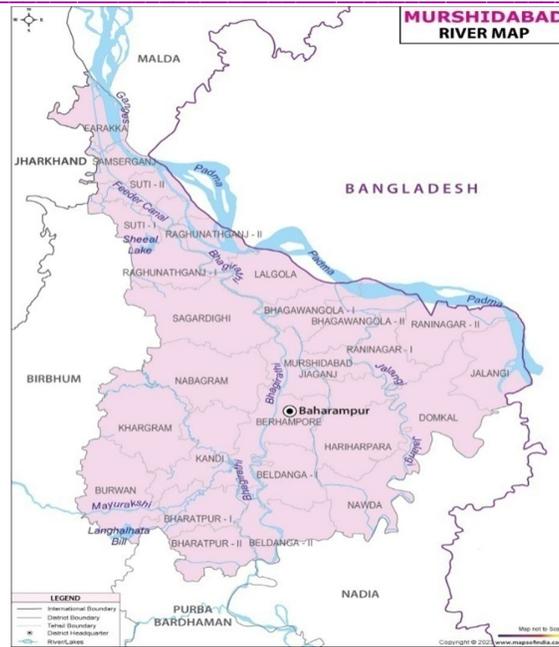
## A RIVER'S SHIFTING COURSE

The changed route of the Ganga, upstream and downstream of the Farakka Barrage, and the erosion of its banks

Source: 'River bank erosion hazard study of river Ganga, upstream of Farakka barrage using remote sensing and GIS' by P.K. Thakur et al (2012)
